Studies on the Value of Cultural Heritage n. 31, 2025

Fire Risk Analysis with Risk Matrix Method in Historical Wooden Mosques as Cultural Heritage

Muammer Yaman*

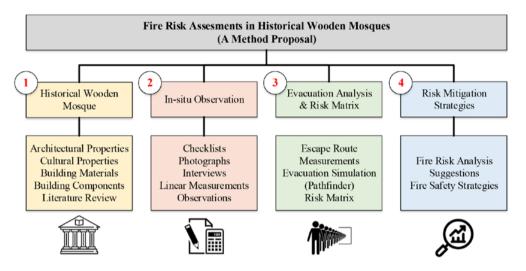
Fig. 1. Method and process of the research (by author)

A fire escape plan for Göğceli Mosque was prepared to conduct detailed research of the historical building within the scope of fire risk assessments; exit distances were calculated. Additionally, a fire evacuation simulation was made according to the most intense use situation of Göğceli Mosque. The evacuation simulation of the case study was carried out through the Pathfinder Thunderhead computer program (Pathfinder 2024.01.0605). Pathfinder Thunderhead is an evacuation assessment simulation tool that is simple to use, good to visualize, and easy to implement. Pathfinder uses Agent Based Modeling (ABM). This approach allows simulation of the behavior and interactions of evacuees and modeling of the behavior of large groups¹⁸. The smoke detectors in the enclosed space operate directly during a fire and provide information to the occupants. Additionally, the spatial organization being a centrally-planned mosque strengthens communication and interaction among occupants. This enables the fire to be detected more quickly and easily, and also allows for a quicker response time. Therefore, the pre-evacuation time has been excluded from the scope of the evacuation analysis. The impact of smoke on occupants during evacuation involves different calculations and analyses, which are not within the scope of this paper. The evacuation simulation was carried out in a scenario where, during any fire, all occupants directly moved to escape and participated in the evacuation process. All methods and processes applied in the research were prepared through diagrams (fig. 1).

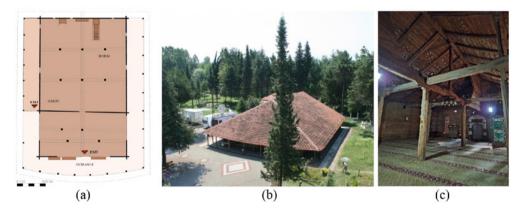
Fig. 2. Göğceli Mosque plan and exits (a) (Furtuna, 2018, adapted), Outdoor environment (b) (adapted from the official accounts of Çarşamba Municipality) and Harim (c) (by author)

The Harim is entered through a single door in the center of the north facade. Inside the Harim, there are two rows of pillars in groups of three arranged parallel to the mihrab wall (qibla wall). These pillars are distributed in a balanced manner within the Harim. The two pillars in the middle of the groups of three are placed on the door-mihrab axis. The pillars generally have a polygonal cross-section (approximately 22-30 cm in diameter) and it is understood that most of them were renewed over time²¹. The dimensions of the wooden panels used on the facades of Göğceli Mosque are quite large, and with these large panels, spacious Harim was created using the masonry technique. This unique approach is one of the elements that make the architecture of the mosque unique. The Harim is illuminated by two windows on the east and west facades. The windows located close to the mihrab wall are slightly smaller. Additionally, a total of six ventilation holes were opened on the mihrab wall in the form of crenellations arranged in two rows, one above the other (lower row windows are measured 30*35 cm externally and 23*27 cm internally). The ones close to the ground were covered with iron cages. However, the light from four windows was insufficient to illuminate this large building. Therefore, the Harim has a half-light or half-dark atmosphere.

The Harim and the narthex are surrounded by a single row of cloisters on the north, east, and west facades. Especially the entrance cloister on the north facade offers an unusual and different arrangement. This cloister is supported by a total of eight pillars and the pillars are placed in the form of a convex arc on the facade. The width at the corners of the cloister is 1,80 m, while the width in the center is 2,43 m. The cloisters on the east and west facades are formed with ten pillars arranged at equal intervals. The width of the side cloisters is 2,42 m. The cloister on the eastern side was later divided at a point close to the center at the level of the northern wall of the Harim, and the part of the cloister extending along the Harim was converted into a women's mahfil by closing the exterior facade. A single door was used for the partition²³. The cloisters were covered by extending the roof cover of the main building with the same slope. Due to this design, when viewed from a distance, the mosque has a very flattened appearance as if it has collapsed to the ground. According to some remains and statements of region people, the outer side of the cloisters was surrounded by 1 m high wooden railings²⁴. These details add a unique touch to the architecture of the mosque (fig. 2).

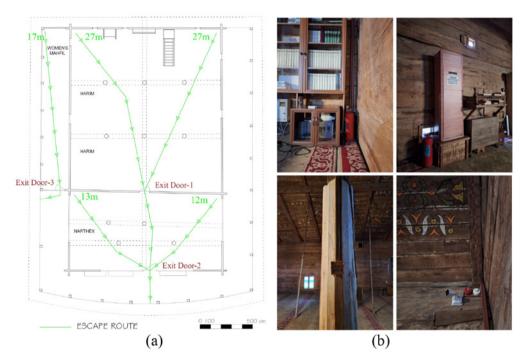
Fig. 4. Escape distances in the plan of a historical wooden mosque (a) and portable fire extinguishers and fire warning-alarm and smoke detection systems (by author)

The fact that the mosque is a centrally-planned mosque within the scope of evaluation and regulation principles from fire risk analysis does not make it possible to create compartments. However, it has been determined that building materials and building elements cannot provide the necessary performance within the scope of fire risks as a result of the past centuries. Especially the deterioration and structural collapse of wooden elements in contact with the exterior proves the magnitude of this risk. The fact that the cables are exposed and allowed to circulate throughout the building without taking precautions in the openings inside the building poses a threat in terms of fire. The historical building has fire department access in case of a possible fire. However, the roads accessing the building should be widened in this context and a more comfortable maneuvering area should be created. There are portable fire extinguishers indoors. However, there is no hydrant system outside, there are fountains to supply water. There is fire detection (smoke detectors) and warning systems in the historical building. Smoke detectors were installed where the roof meets the wall, rather than at the highest point. This placement could reduce their effectiveness due to the way smoke spreads. During a fire, smoke alarm systems may not be fully efficient, relying more heavily on occupants visually detecting fires rather than being alerted promptly by the detectors. Due to the lack of alternative escape routes for escape distances, one-way exit (common path) distances (approximately 27 m) were examined and found to be high distances for a historical building without automatic sprinkler systems (fig. 4)³⁸. No obstacles were encountered on the escape route. However, it is thought that opening the exterior escape doors to the interior may pose a risk for congestions during escape. Since it is a direct circulation door, it is not locked. It was determined that exit signs for the escape were insufficient in the wooden historical mosque. However, providing exits through the door used for common entrance reduces the need for guidance.

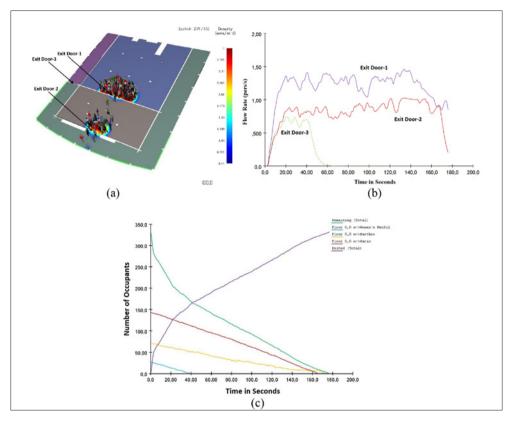
Fig. 5. Congestions at 100th s (a), flow rates at exit doors (b) and room evacuation and total evacuation time (c) (by author)

Evacuation analysis was performed at full occupancy capacity of the occupants of the historical wooden mosque. In the evacuation analysis, it was assumed that the occupants consisted of elderly individuals as the riskiest group and the speeds were taken as 1,05-1,2 m/s for men and 1,04-1 m/s for women³⁹. Simultaneous total evacuation time during fire evacuation was analyzed. In the evacuation simulation, the occupants in the mosque are considered randomly distributed. The total evacuation time of the occupants (332 people) was 176,3 s (approximately 3 min). Congestion represents a recurrent condition over simulation time at Exit Door-1 and Exit Door-2. A scene from the evacuation simulation is presented where the flow rate at Exit Door-1 is minimal during the congestion period (fig. 5). Depending on the number of occupants in the historical wooden mosque, the total evacuation time was too high for buildings of similar building class. Yaman and Kurtay found that a much higher number of occupants (1131 people) evacuated in about 3 m depending on different scenarios⁴⁰. Azkur and Oral determined a total evacuation time of 10 m 48 s with a high number of occupants (2849 people) in a mosque⁴¹. Toprakli and Satir determined the total evacuation time between 8 m 20 s (Süleymaniye Mosque; 4799 people) and 2 m 46 s (Kılıc Ali Pasa Mosque; 1141 people) depending on the high occupant's number in their evacuation analysis in various historical mosques⁴². The fact that the exit doors from the Harim and the narthex (son cemaat mahali) as the main space are non-alternative and narrow (bootleneck) caused congestions at these points. In the women's mahfil, it was determined that the total number of occupants was completely evacuated within the first 60th s.
